# **Assessment of the load-bearing capacity of a historic glued laminated timber structure**

*Influence of chemically-aggressive media on the load-bearing capacity of timber members*

Research Workshop

„Contextualizing Early Glulam – The Change in Timber Technology in the 19th & early 20th century“  
24./25. January 2019 – ETH Zurich – Department of Architecture

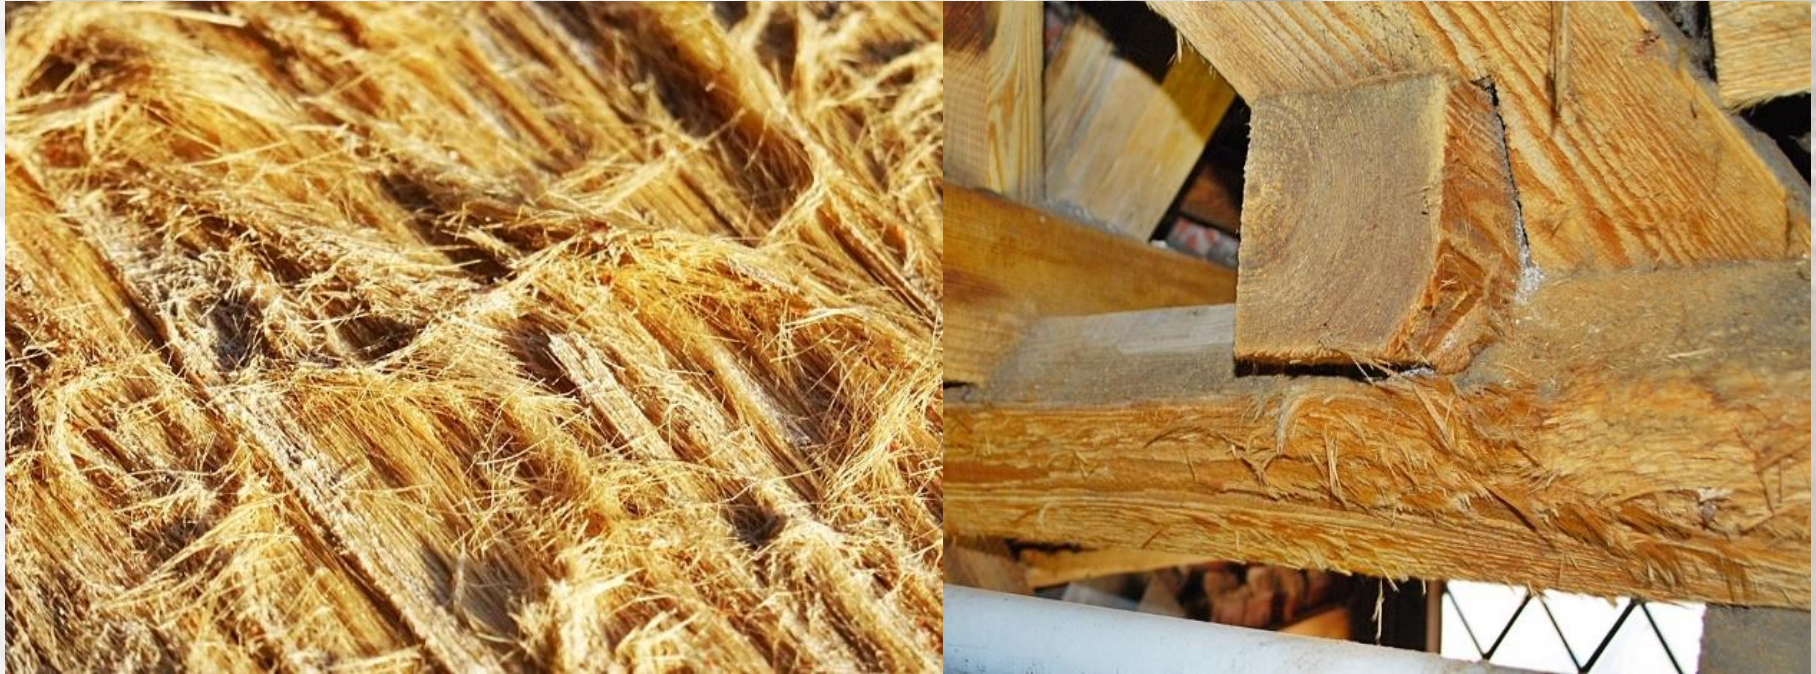
typical appearance of the wood corrosion – left: fibrous surface structure; right: Oberflächenstruktur; rechts: shedding of the superficial wood structure as fibre bundles or wood strips

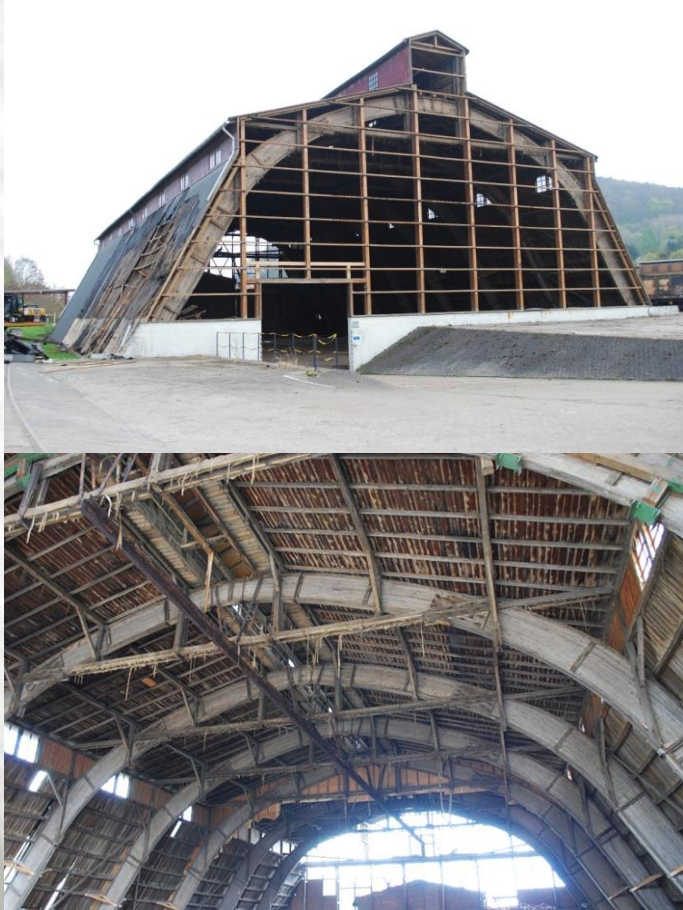
top: external view; bottom: internal view

- erected 1912 by the Otto Hetzer AG, Weimar
- used approx. 80 years as warehouse for fertilisers
- demolished in April 2010
- Parabolic trusses – HETZER construction method (spruce wood)
- Span width: 32m; height: 14,5m
- greyish-brown discolouration
- fibrous surface structure
- shedding of superficial structure
- Heavy corrosion on the connectors and steel members

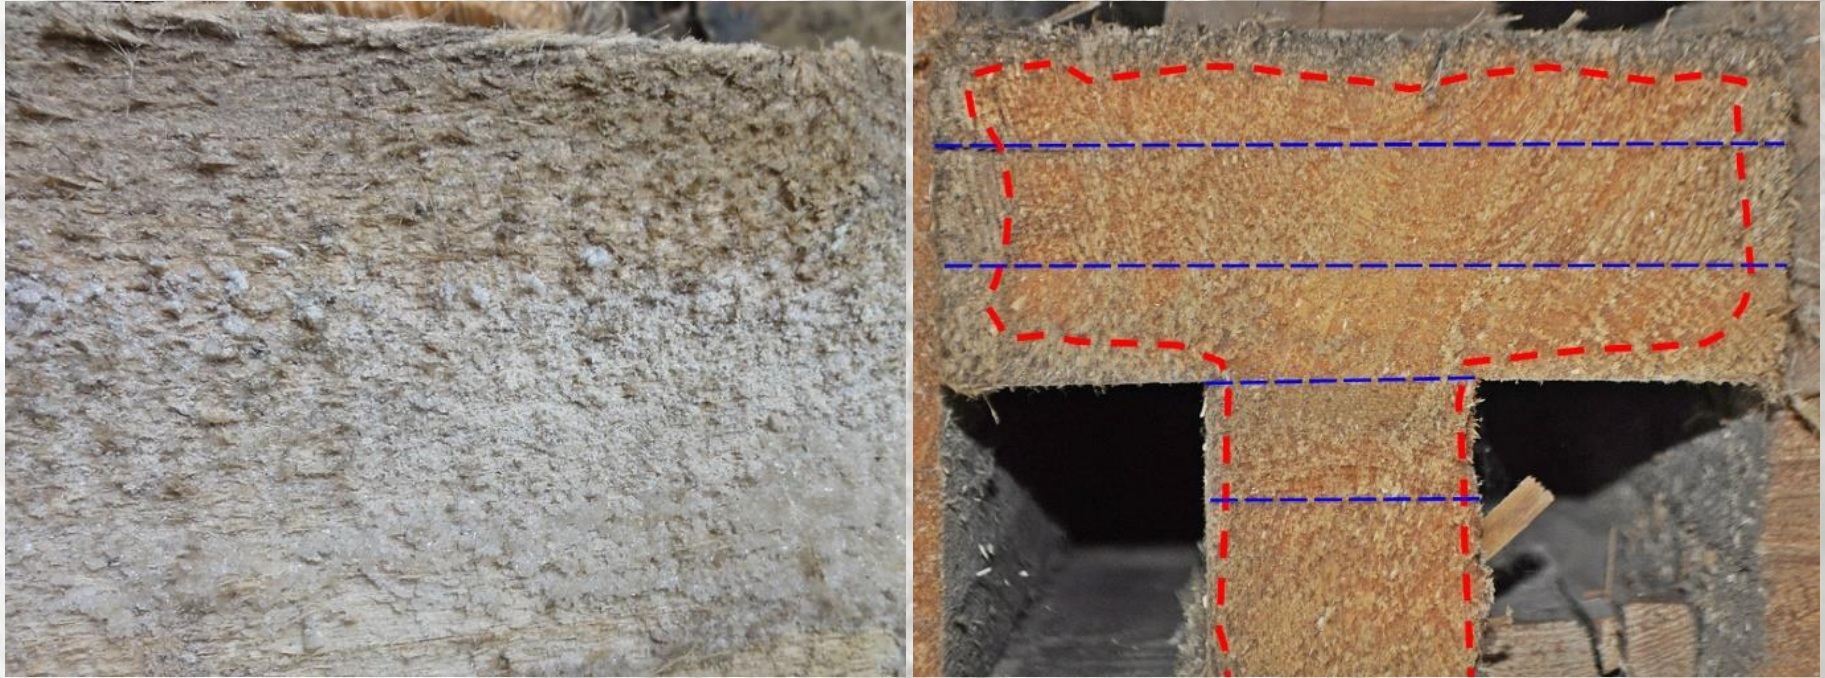
Clearly visible marks of corrosion

left: fibrous surface structure and greyish discolouration as well as salt deposits; right: discolouration of the superficial structure (red dashed lines: discolouration border; blue dashed lines: glue joints);

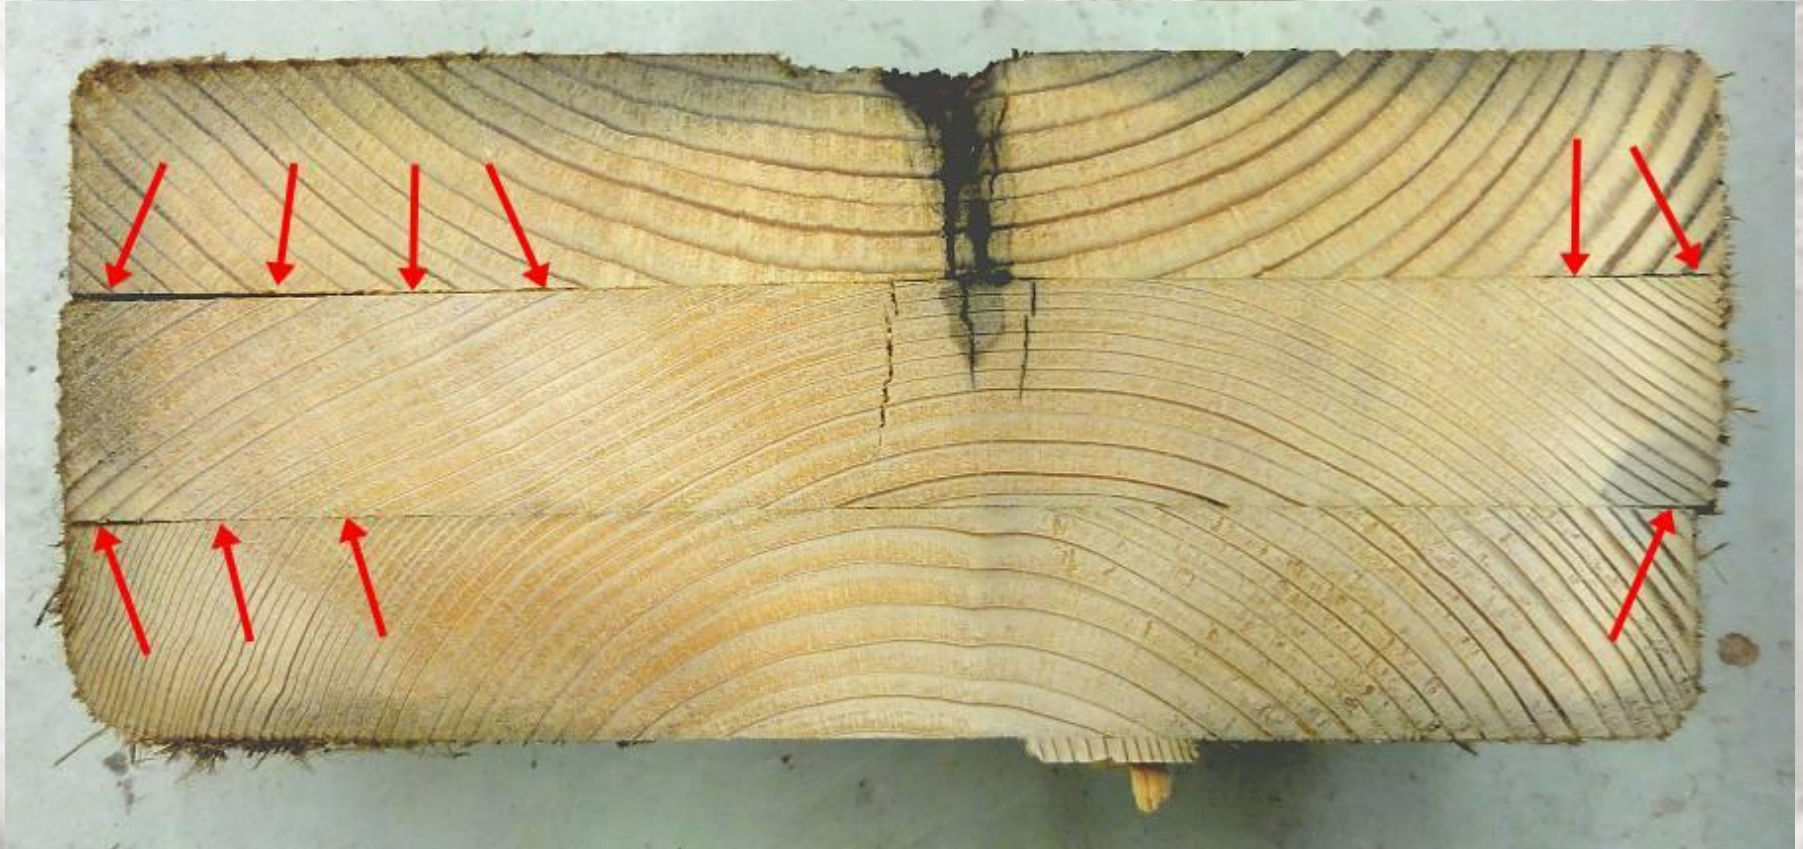
Loose glue joints in the periphery of the chord's cross section

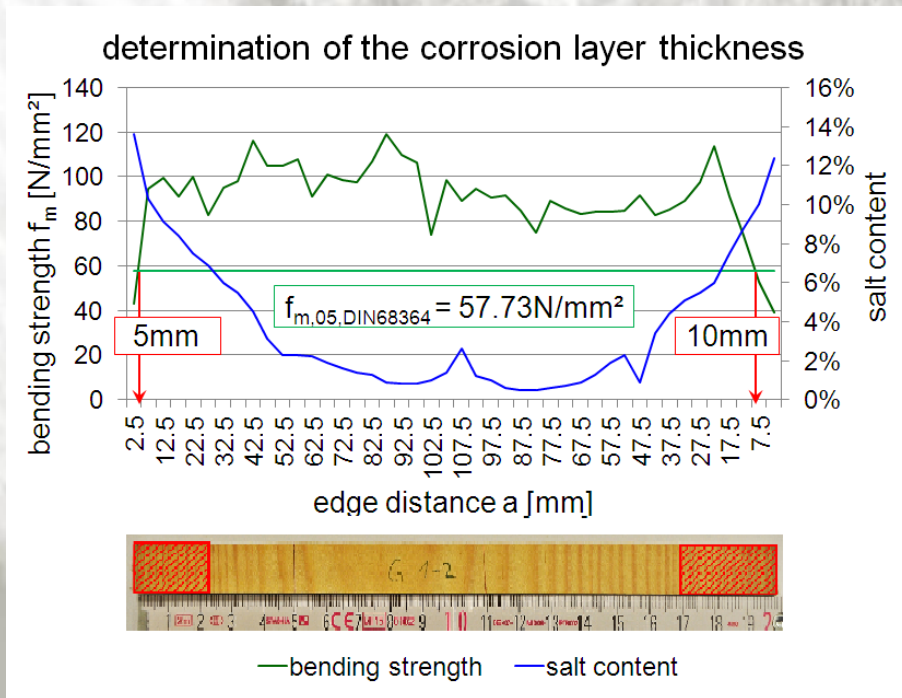
Determination of the corrosion layer's thickness on the basis of the bending strength depth profile according to the relevant literature

Thickness of corrosion layer:

chords: approx. 13,5 mm

web: approx. 11,0 mm

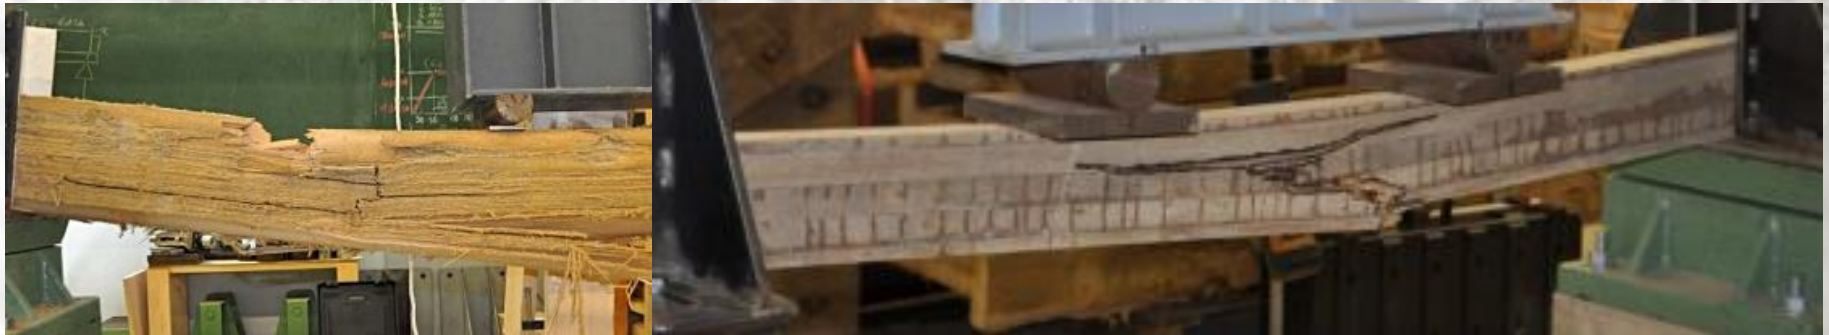
Bending tensile/ compressive on solid and glulam timber

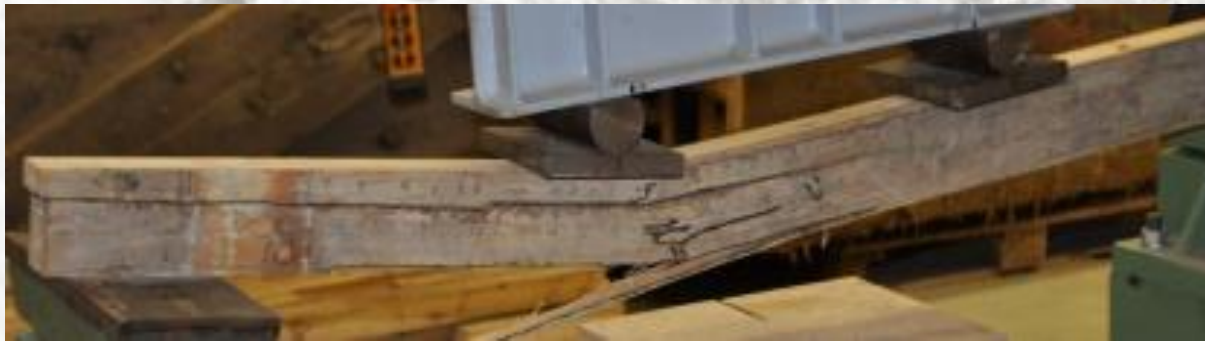
Additional shear fracture on glulam timber

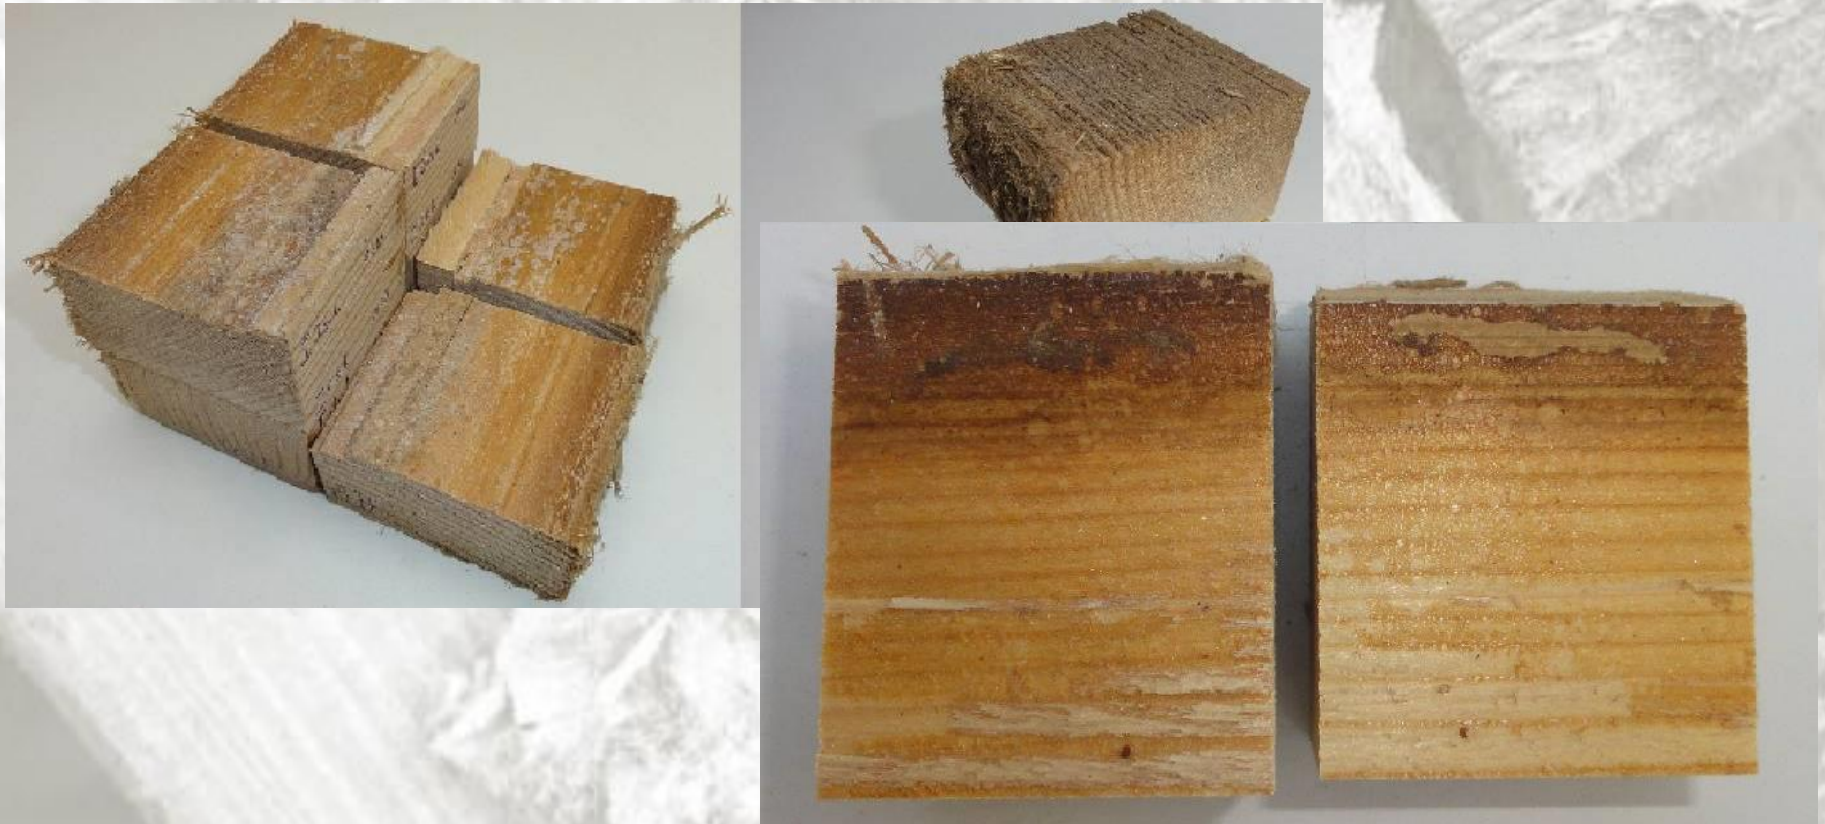
Partially significant damages of the glue joints due to the influence of the salts as well as moisturisation/drying
