## **New procedure for timber in heritage buildings - the case study of Castle Friedenstein, Gotha (Germany)**

### **Abstract**

#### 4. Castle Friedenstein, Gotha (Germany) – A case study

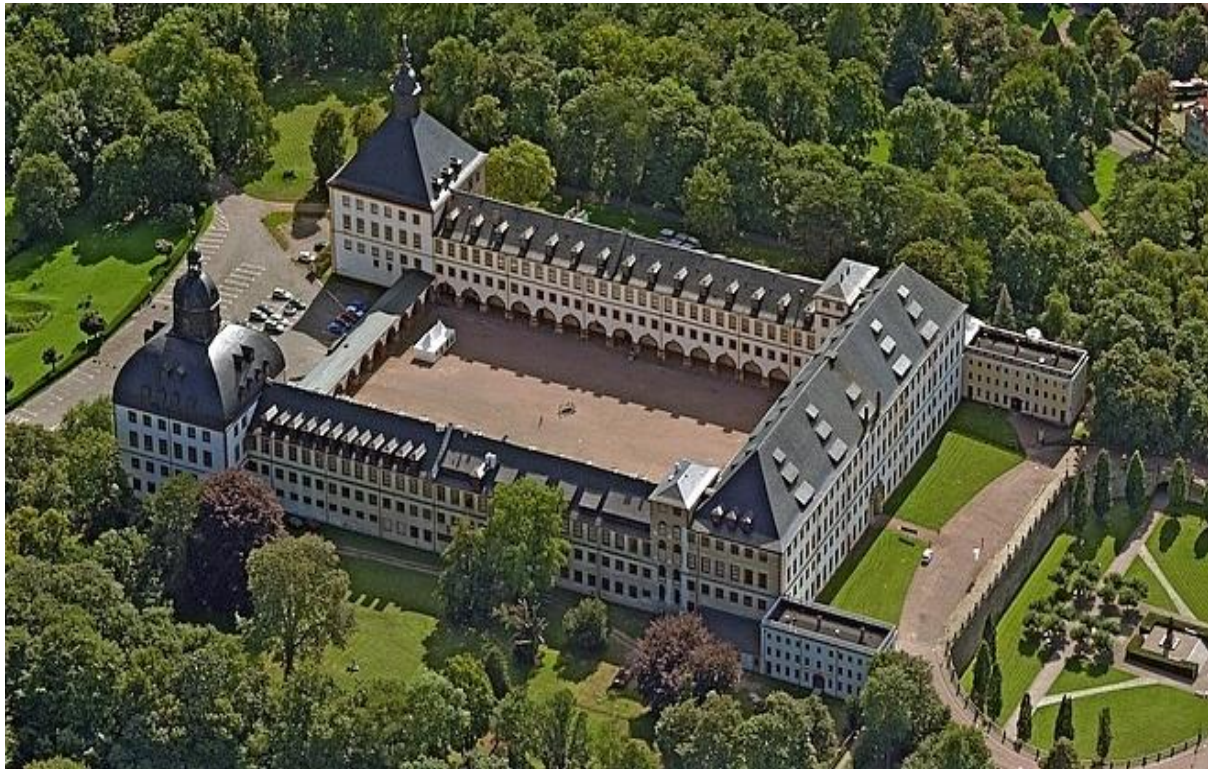
**Figure 1:** Aerial photograph of the Friedenstein palace complex source: [STSG, 2017]

The actual palace is one of the biggest palaces of its kind (Fig. 1). It was constructed as huge, a four-winged building and four-stories high. It consists of the main building situated in the north wing, the adjoining three-story, east and west, wings, and the gate building in the south. The length of the north

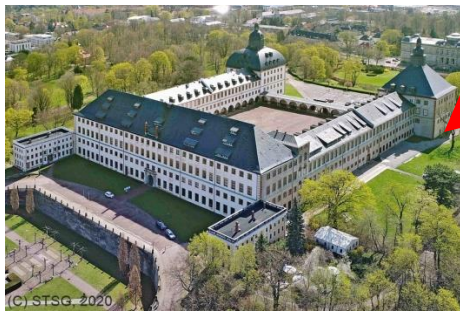
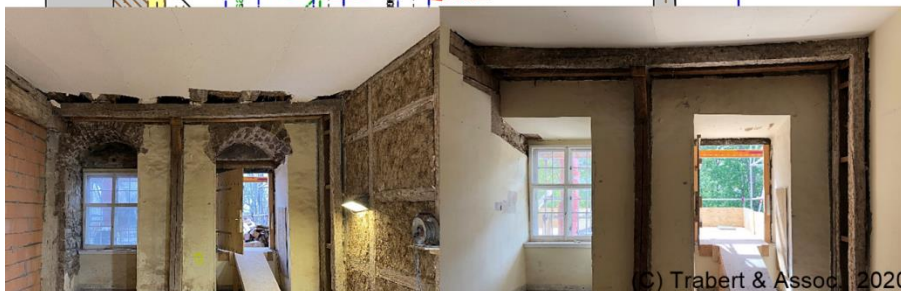
**Figure 3:** Top; the location of investigated ceiling is marked in red, Middle: mapping of organic damages and Bottom: interior view on the ceiling.

Since 2018, extensive redevelopment work has been carried out on the west wing. In addition to repairing the foundations (masonry pillars), the wooden roof construction and the historic stucco ceilings, a barrier-free access is also being constructed. In the course of this, parts of the historic ceiling constructions between the first and second floor of the west wing have been dismantled (see Fig. 3).

The investigated ceiling showed partial damage due to wood destroying fungi along the exterior wall (see Fig. 4). In the course of previous redevelopments the ceiling beams were already supported with additional joists and columns (see Fig. 3, bottom and Fig. 4).

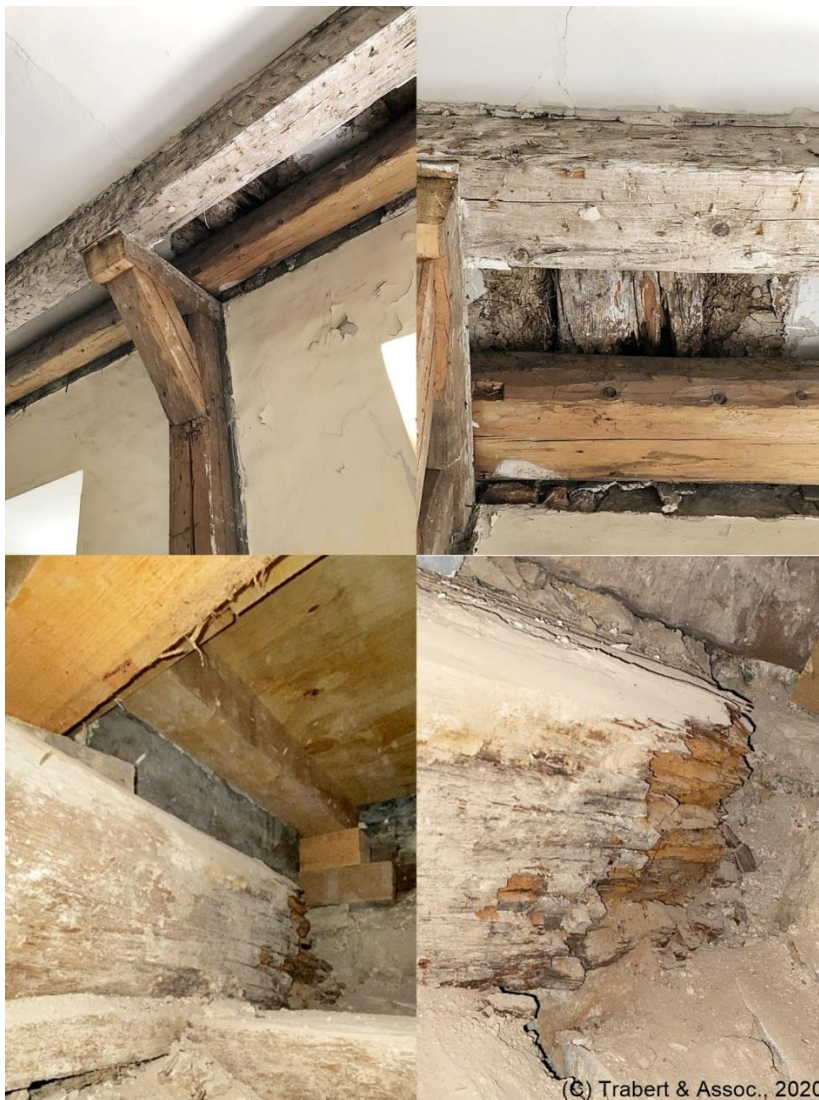
**Figure 4:** Illustration of state of the timber beams

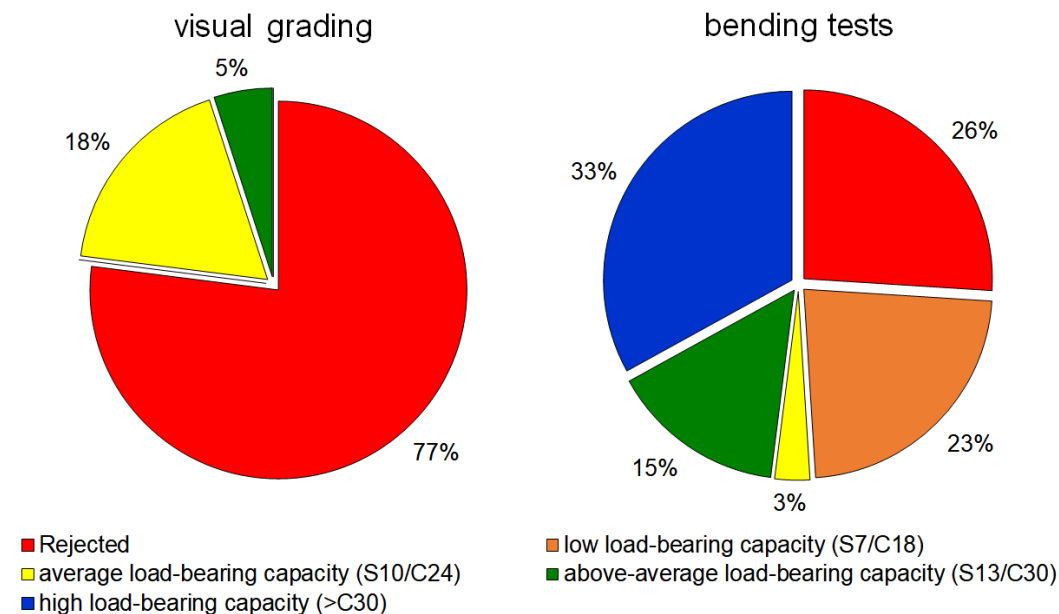
**Figure 5:** Comparison of the results of the visual grading and the destructive bending tests.

Taking into account the fact that the floor beams did not fail due to overloading, severe deformation or even the present organic damage and that their load-bearing capacity was still as given after nearly 370 years, the results of the visual grading show that a strict application of the grading rules developed for new construction timber is not suitable for assessing the material quality of timber components in existing constructions without a more detailed assessment and the use of additional measuring and test methods. This becomes particularly clear when comparing the results of visual grading with grading based on destructive bending tests (see Fig. 5).

The in-situ strength grading method made it possible to estimate the load-bearing capacity of the sample material more precisely. Depending on the strength grading level, the overestimation of the actual load-bearing capacity determined by testing was (6...15) %. The reliability of the sorting method is therefore given. Furthermore, it has been shown that comprehensive strength grading of timber components in existing constructions can in some cases reveal considerable load-bearing capacity reserves that can be used in the evaluation of structural stability. As already described, an average load-bearing capacity is usually assumed. For softwoods, this corresponds to strength class C24 according to EN 338 or a characteristic bending strength of 24 N/mm<sup>2</sup>. With the help of in-situ strength grading, some of the sample material could be assigned to strength class C40 according to DIN EN 388, which has a characteristic bending strength of 40 N/mm<sup>2</sup>. This results in a load-bearing capacity reserve of 67 %.
