# **Assessment of the load-bearing capacity of a historic glued laminated timber structure**

*Influence of chemically-aggressive media on the load-bearing capacity of timber members*

Research Workshop

„Contextualizing Early Glulam – The Change in Timber Technology in the 19th & early 20th century“  
24./25. January 2019 – ETH Zurich – Department of Architecture

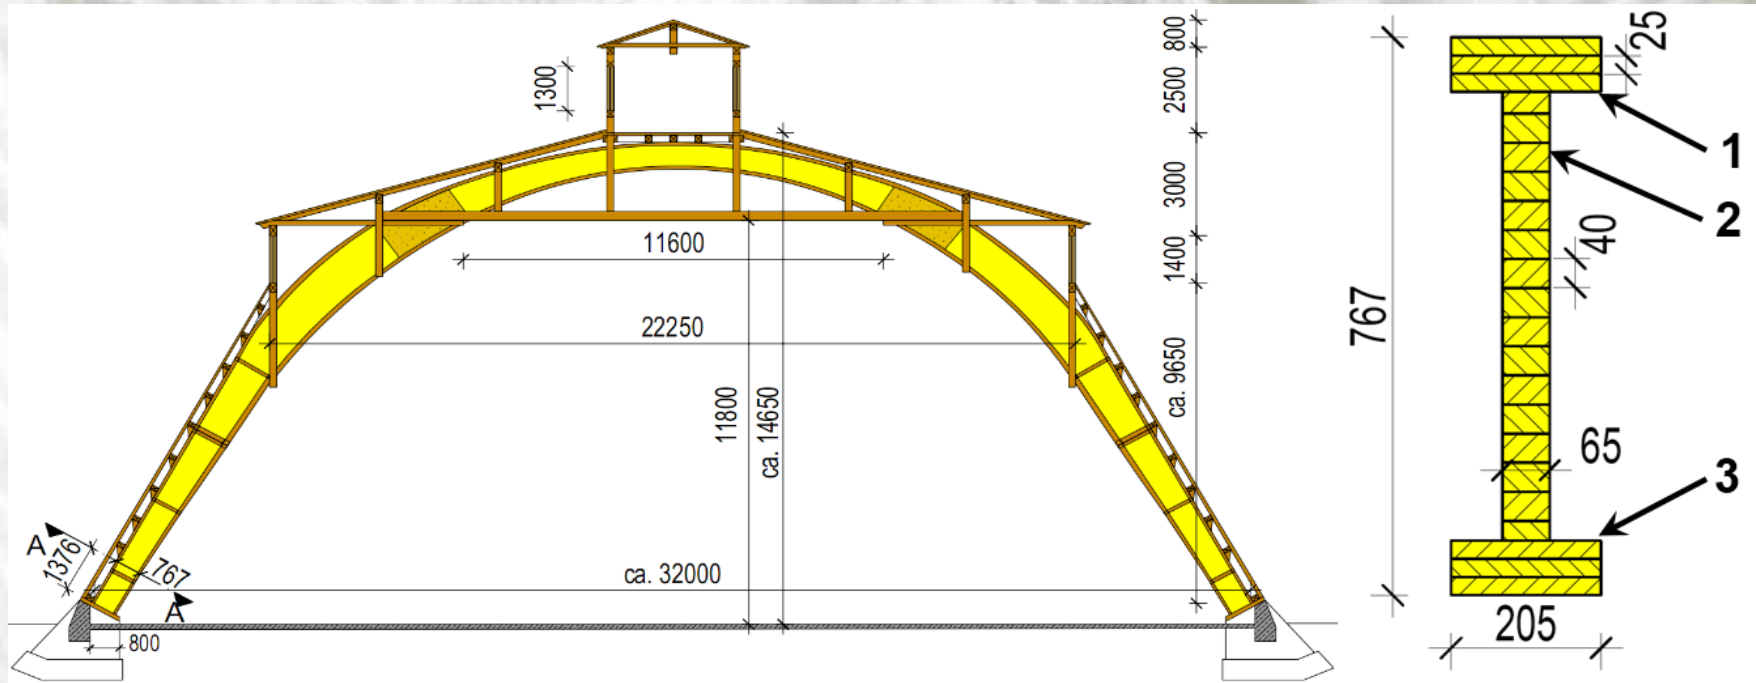
Grafic depiction of the load-bearing structure:

left: parabolic glulam timber trusses; right: cross section A-A (1 ... top chord; 2 ... web; 3 ... bottom chord)

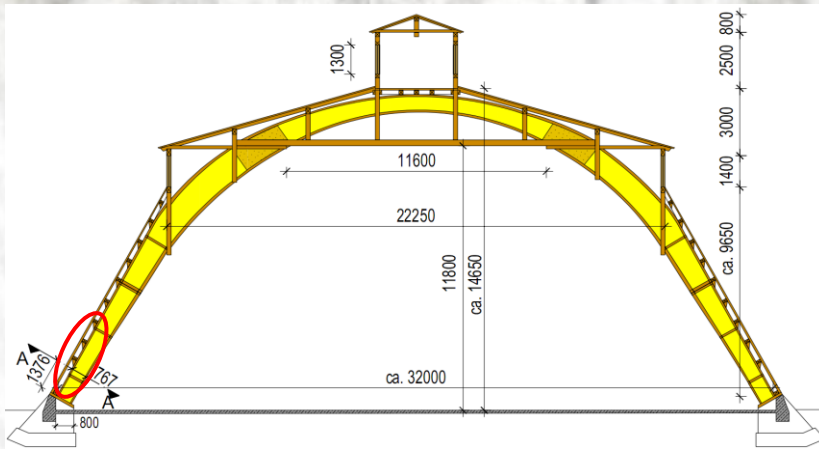
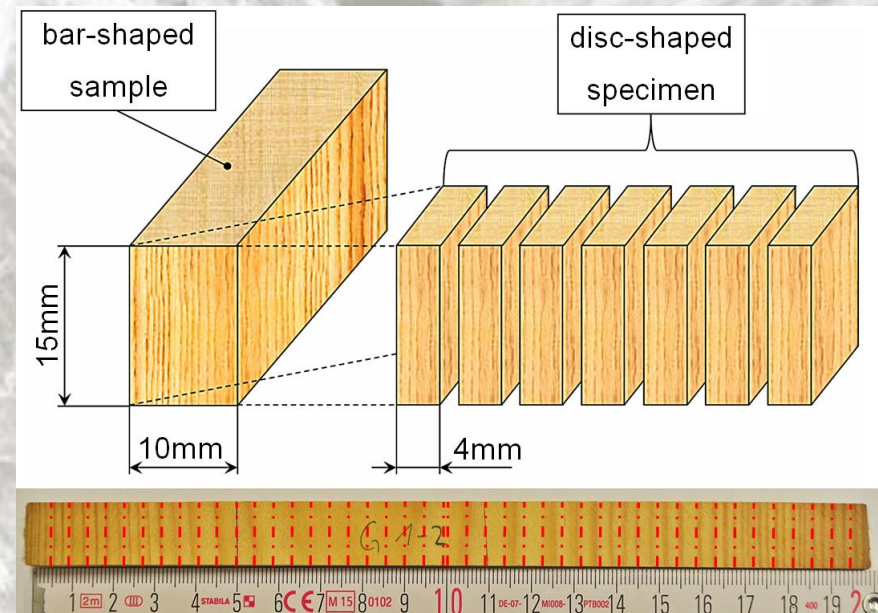
Sample series „chord“: 30 samples with 44 specimen → 1320 specimen

Sample series „web“: 30 P samples with 14 specimen → 420 specimen

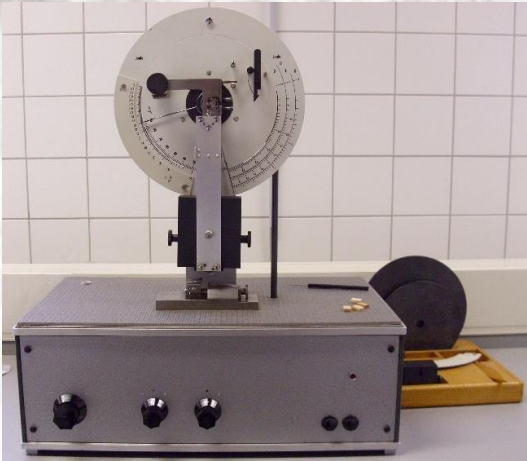
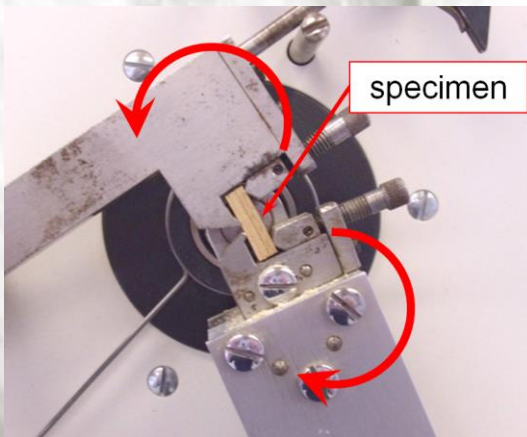
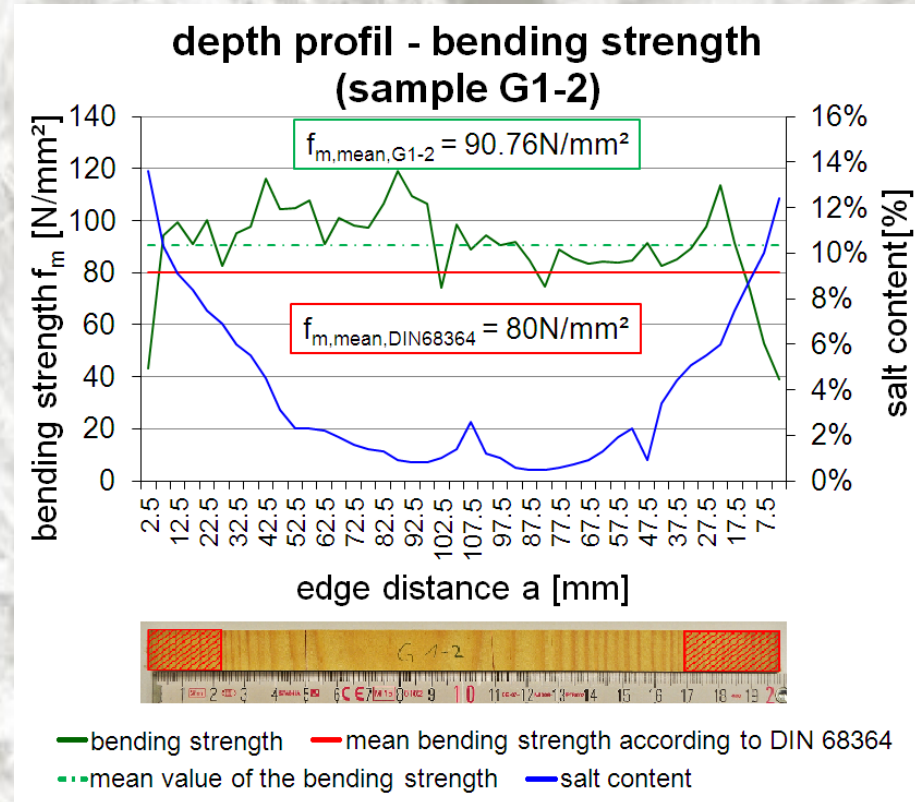
Determination of the bending strength (Dynstat-method)

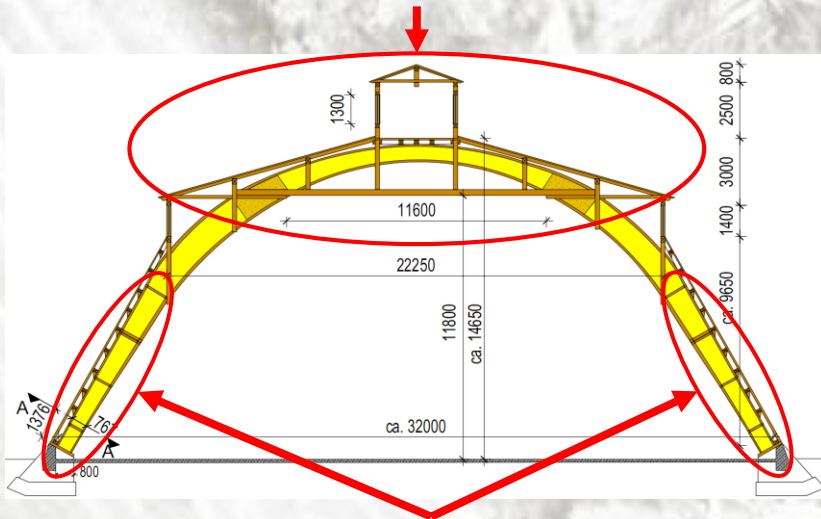
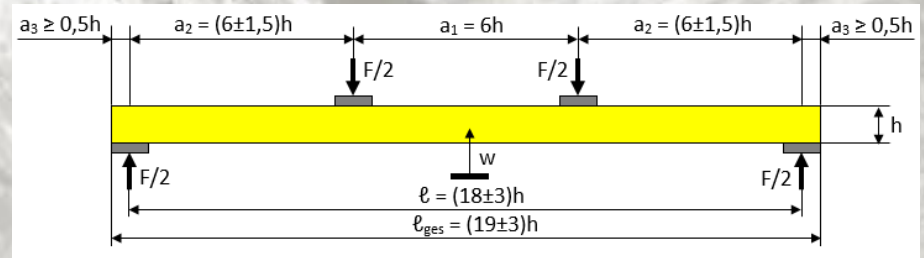
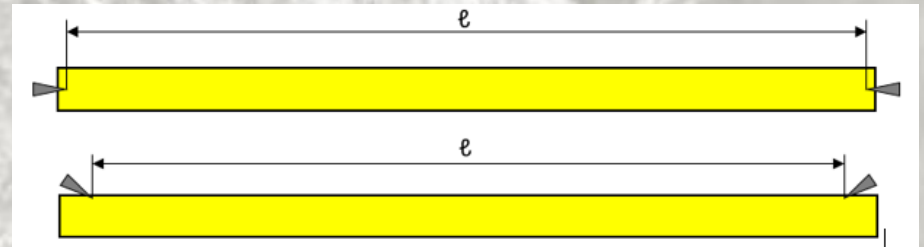
Bending test acc. EN 408

Ultrasonic time of flight measurement

Sample series „VH“: 40 specimen from the roof structure

Sample series „BSH“: 40 specimen from the glulam trusses

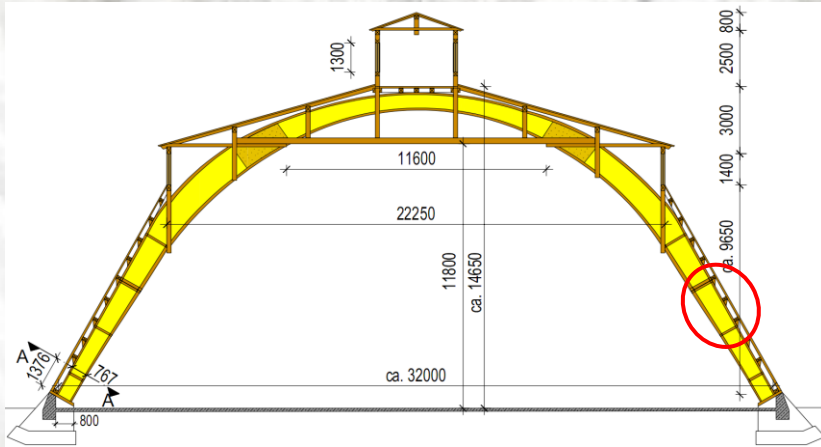
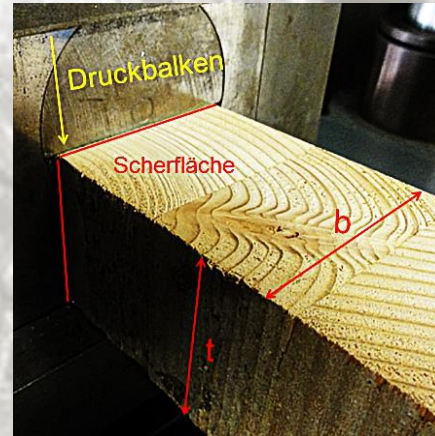
Shear test acc.  
EN 392

Samples: 314 glue joints extracted from the chords and webs of two Truss fragments

- Mean shear strength of 4,3 N/mm<sup>2</sup> (chords) and 4,9 N/mm<sup>2</sup> (webs)
- Mean fiber fracture ratio: 59%
- Requirements of the nowadays valid standards are not fulfilled → only valid for synthetic resin glues
- Comparison with literature on the strength of casein glue joints shows that the shear strength of the studied materials equals the shear strength of new casein glue joints
- Therefore, the salts influence on the shear strength is only marginal

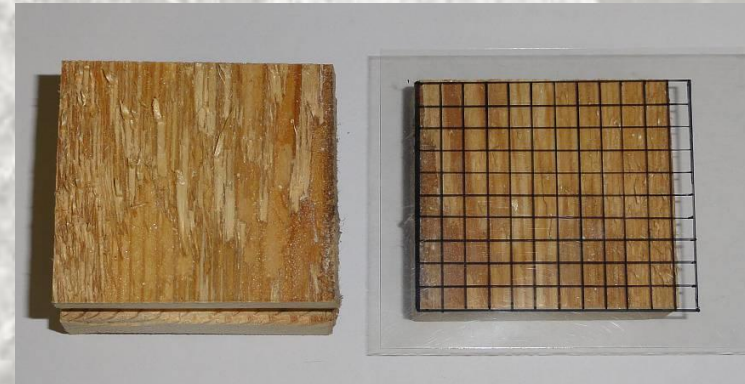
Determination of the fiber fracture ratio
